⑥ National Dam Inspection Program
Star Junction Number 1 Dam
(NDI Number PA-00198, PennDER
Number 26-30) Ohio River Basin,
Washington Run, Fayette County, Pennsylvania.

Phase I Inspection Report

STAR JUNCTION NO. 1 DAM
FAYETTE COUNTY, COMMONWEALTH OF PENNSYLVANIA
NDI NO. PA 00198
PennDER NO. 26-30

Prepared by: ACKENHEIL & ASSOCIATES GEO SYSTEMS, INC.
Consulting Engineers
1000 Banksville Road
Pittsburgh, Pennsylvania 15216

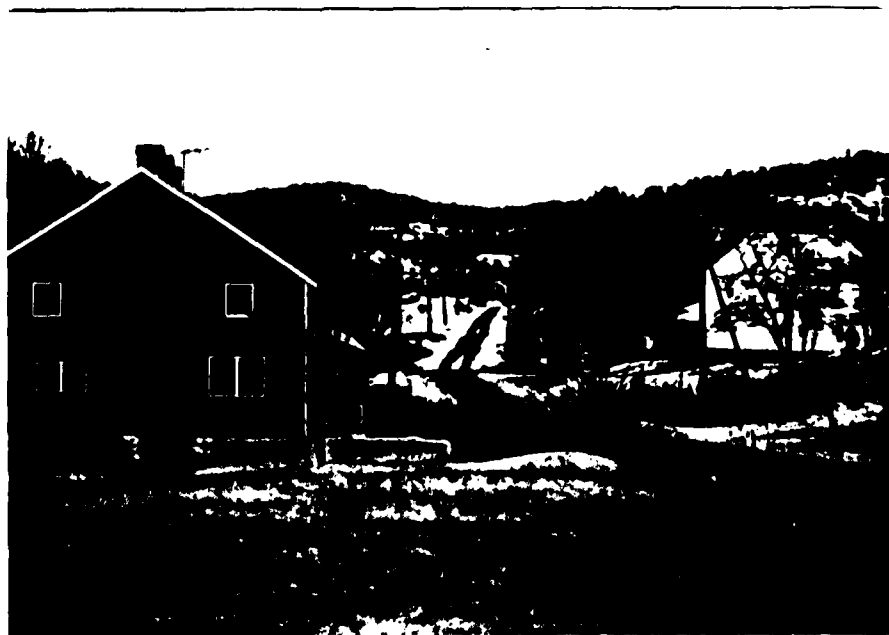
PHOTO 17. DOWNSTREAM VIEW FROM EMBANKMENT CREST
